E&P Works with Service Company to Solve for Increased Longevity of Oseco Safety Plug

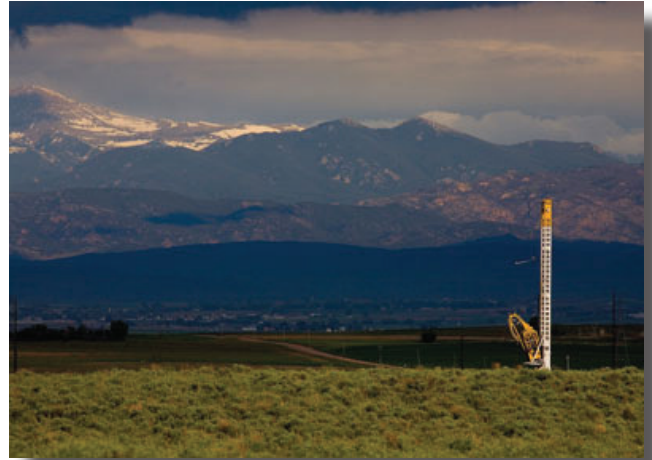
Background - During 2016, a prominent energy company was experiencing difficulty with pressure management while completing wells in Colorado. They contacted Oseco to request troubleshooting assistance. An Oseco Consultant for Pressure Management Operations, met onsite with a team to identify causes of the Oseco Safety Plug's suspected premature activation.

Issue - At that time, crews were experiencing up to three activations per week. Together the group identified three possible causes for these seemingly premature activations:

1. Leaking Plug valves during pressure test
2. Isolation valve opened to Safety Plug after pressure test bleed down
3. Lack of bleed off during line fill to eliminate air

Outcome - Through process analysis and collaboration with the Service company, the team ultimately identified the root cause: *Water hammer effect from opening isolation plug valve to Safety Plug with ~3,000 psi behind it*

Solution: Bleed down pressure to <1000 psi before opening valve

Since implementing the change, the crew has not experienced another premature activation and the life of the Safety Plug has been extended, currently to 300+ hrs. and rising. Personnel are pleased with the performance of the Safety Plug since making the change. Working closely together with the Service company on this issue identified a key operational fix and created added value for the crew while keeping the location safe from over-pressurizations and maximizing the value of the Safety Plug through extended use.
